SAFE SAVARI

NEWSLETTER ON ROAD SAFETY

Analysis of Road Crash Causative Factors

Bus vs Bus Crash Near Ayur, Kollam

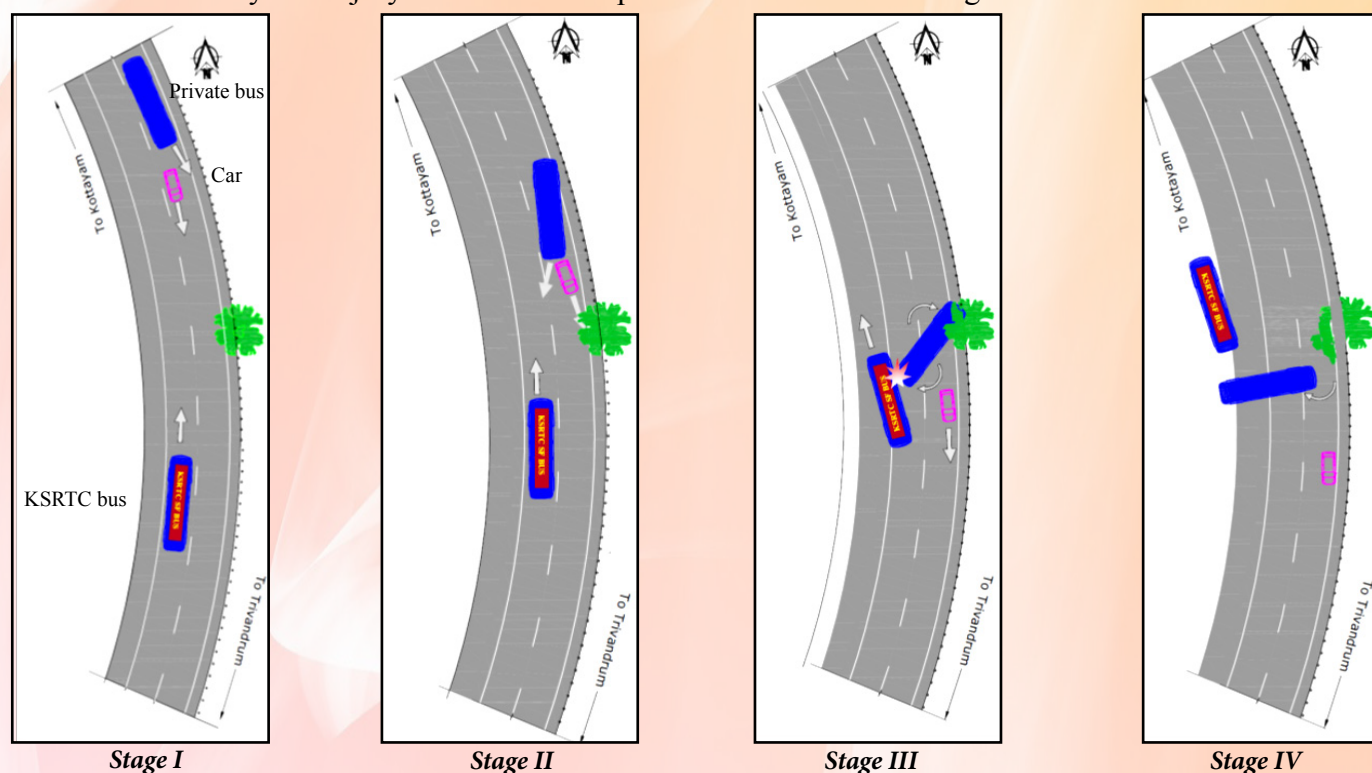
The private bus was negotiating a right hand curve and it was occupied with five persons only, including conductor and driver. The laden weight was very minimal. Drizzle can surely affect the pavement surface grip. As the tyres are retreaded ones, chances are high for skidding or drifting. In these adverse conditions, a sudden turn of steering can generate rotational outward momentum to the rear portion of the bus. Since the vehicle was negotiating a curve the effect of centrifugal force also remains even though minimal. The summation of these two forces can generate substantial outward momentum at the rear portion of the bus. In this case, the counter forces (laden weight and surface friction) available are not sufficient to resist the momentum generated towards outward. As a result the rear portion of the bus was thrown outward. While throwing outward, the rear upper corner of the private bus hit against the branched tree on the edge of the shoulder. The corner piece got pivoted which aggravated the severity of impact on the passing KSRTC bus. This has resulted in causing severe damage towards entire right side body of the KSRTC bus and resulting in increased fatality and injury. The tentative representation of collision is given below.

Tentative representation of collision

The speeding private bus had tailgated a car and tried to perform a forceful overtaking. The tailgating bus generated a sudden reaction on the car driver whose movement was totally unforeseen to the rash bus driver. Thereby the private bus driver on a reflex to avert a crash at the rear of the car have taken a sharp turn. The hitting of the rear portion of the private bus on the branch of the tree at the road edge resulted in increasing the severity of the impact. Thus is concluded that the reason for this crash is the rash and negligent driving behavior on the part of private bus driver.

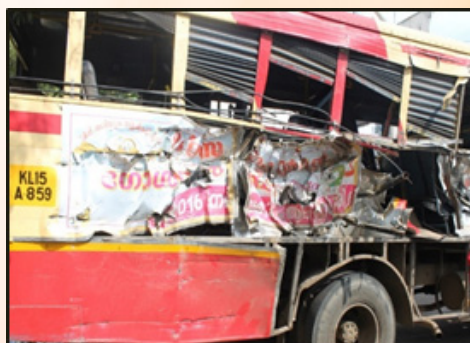
The collision had occurred at the dedicated lane of KSRTC Superfast bus where clear lane violation was evident from the part of the private bus driver. Possible chances of driver error from the part of KSRTC driver were thus ruled out. The tyres of KSRTC bus were retreaded ones with moderate to good surface grip. On inspecting the damages sustained to KSRTC bus, a high velocity impact is evident.

Condition of KSRTC Superfast after crash

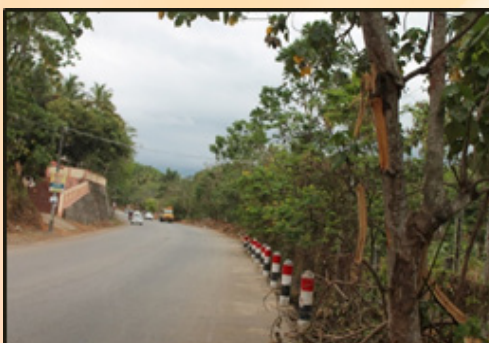
At the crash scene, a lightly visible mark of sudden steering shift of a heavy vehicle's front axle was visible. From the pattern of the impression of front axle on the pavement, it was ascertained that the marking is not because of sudden braking but because of sudden steer attempt that resulted in skidding of the rear axle of vehicle due to centrifugal action on curve. It was also observed that the rear pillar corner piece of the private bus got stuck in the branch of a tree located near the shoulder.

Crash spot and the tree to which the private bus collided

On the basis of the study, the team has suggested certain remedial measures. Speed limit signs should be provided as per standards suggested in IRC 67-2012. Road side elements such as vegetation, protruding trees, concrete obstacles, advertisement boards etc, endangering life of road users and obstructing/distracting driver's view should be cleared or protected. Stretches where geometrical constraints exist have to be cautioned in advance. Open drains should be provided with cover slabs. All street lights should be made functional and advertisements on the poles should be removed. Reflective studs have to be fixed along the entire length in edge lines as well as median lines. Awareness programmes aimed at discouraging rash driving have to be carried out by the concerned agencies. Enforcements should be strengthened.

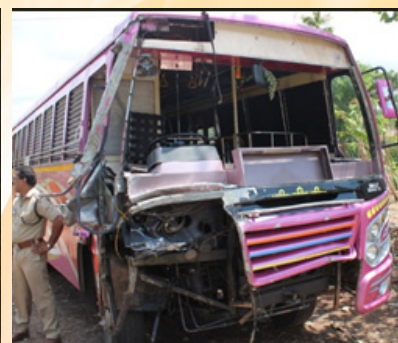
Condition of Private bus after crash

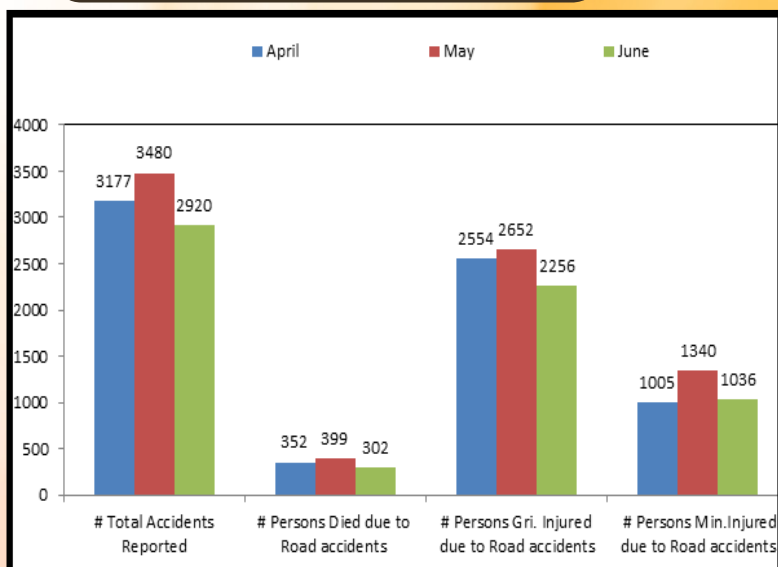
Road crash details of Kerala in April-June 2017

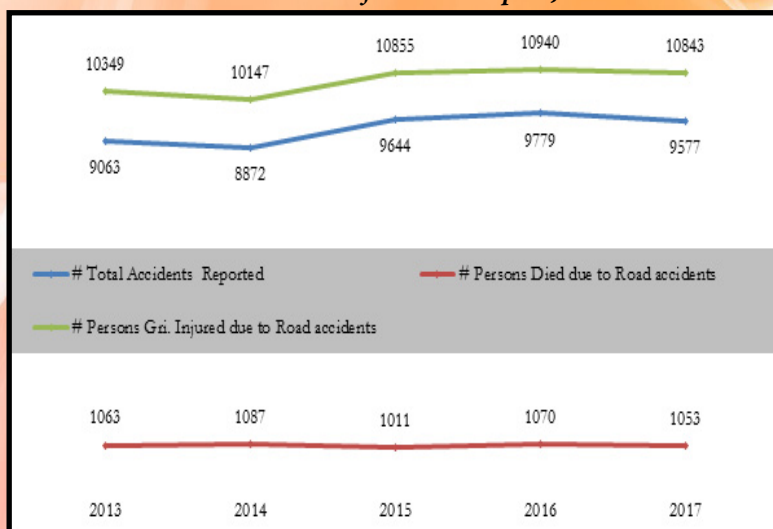
Trend of road crash parameters in April-June of various years
